DART SERVICE INSTRUCTION

TO AMEND INSTALLATION INSTRUCTIONS D206-540 REV. K OR LATER APPROVED REVISION

REF. TCCA STC: SH94-5

REF. FAA STC: SR00386NY

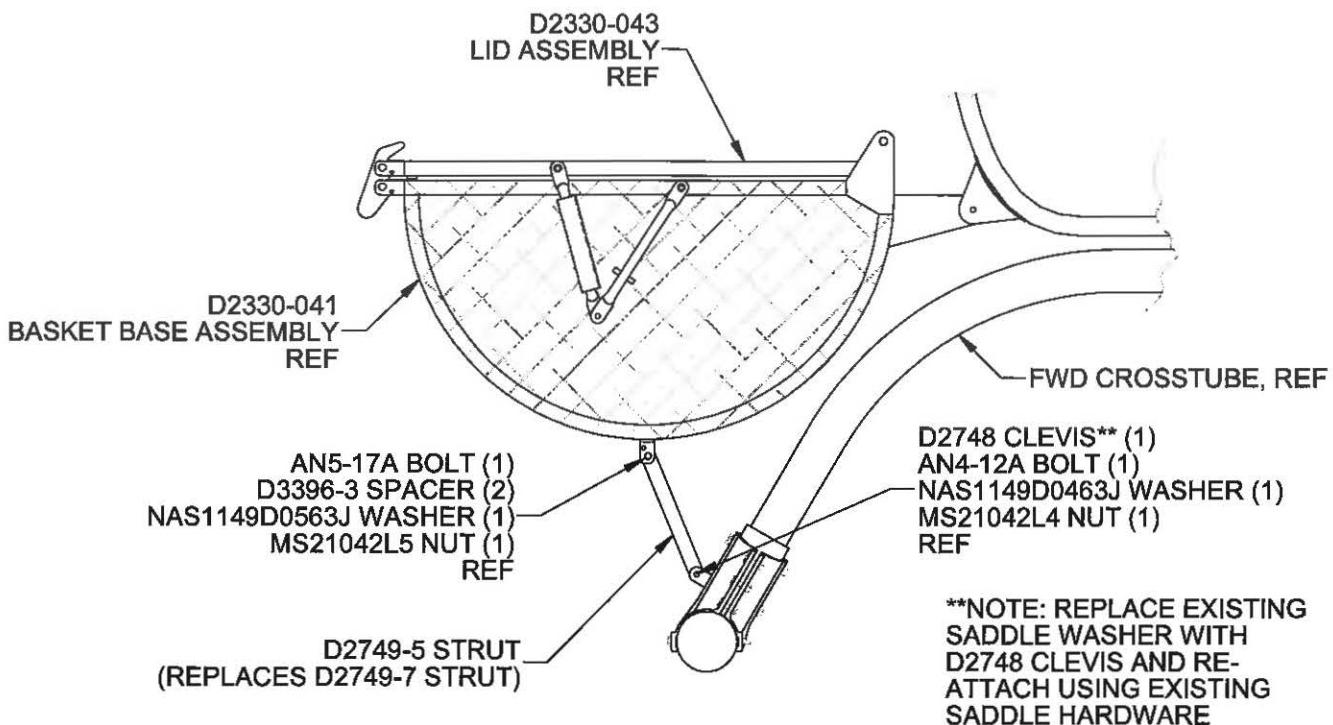
**FIGURE 1: OPTIONAL D206-540-013 INSTALLATION
FWD CROSSTUBE SHOWN
VIEW LOOKING AFT**

It has come to Dart's attention that the D206-540-013 Heli-Utility-Basket may not sit level on some aircraft. On affected D206-540-013 Heli-Utility Baskets, the D2749-5 Strut (available from Dart Aerospace) may be installed in lieu of the shorter D2749-7 Strut as shown below.

The Heli-Utility-Basket should otherwise be installed per Installation Instructions D206-540 and maintained per Maintenance Manual Supplement MMS-D206-540. This service instruction has negligible effect on Weight and Balance.
